# Plum Creek Dam Rehabilitations

May 14, 2025

# Plum 14

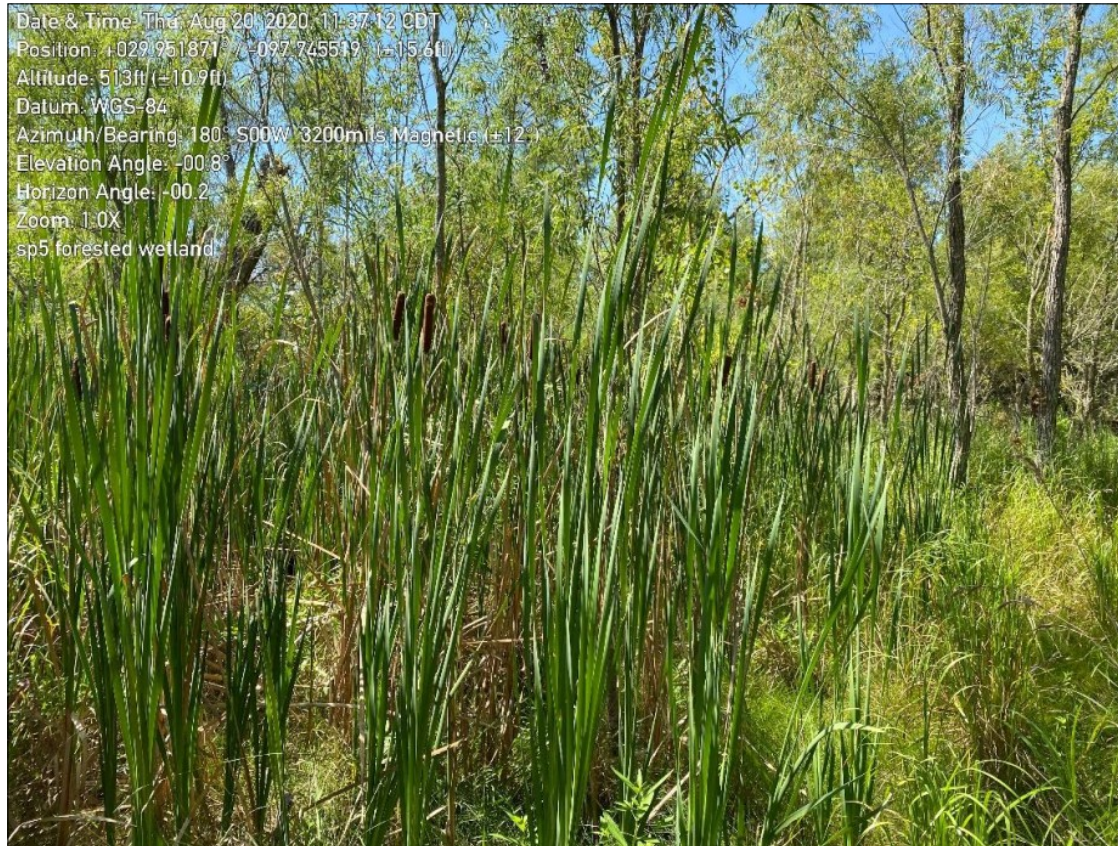
### Forested Wetland Resolution

- Through ongoing coordination, a redesign of construction activities near the forested wetland was completed.
- The redesign was ultimately determined to be satisfactory to the USACE.

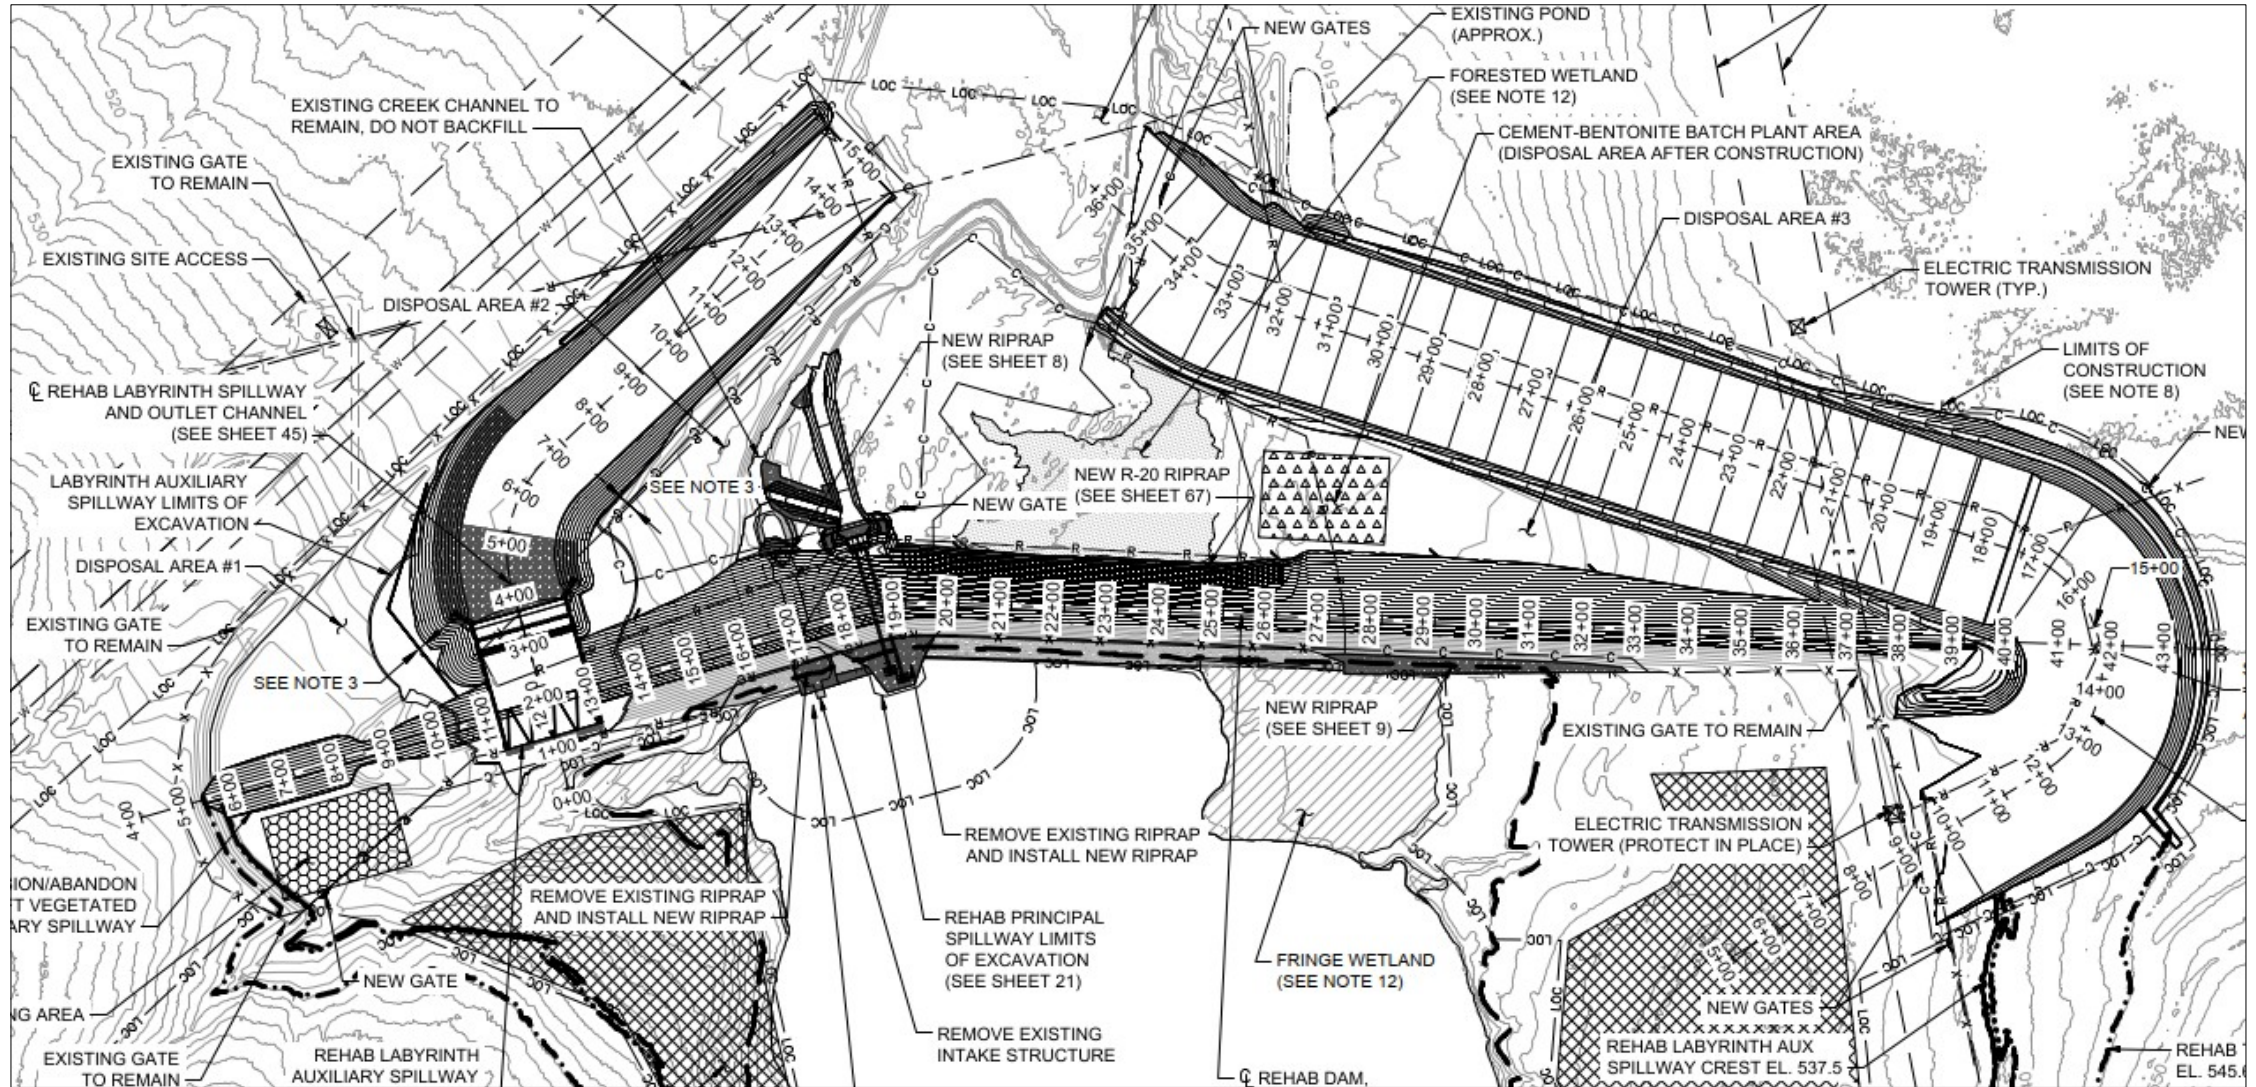
## Relocate Structural Labyrinth Spillway
